THAT'S ONE BIG ROOF APPLICATION WITH BELZONA

Industry: *Buildings & Structures*
 Application: *RPA-Roof Problem Areas*
 Substrate: *Concrete*
 Products: ** Belzona® 3111 (Flexible Membrane) ,*

Customer Location: *Olympic Complex, Algeria*
 Application Date: *December 2003*

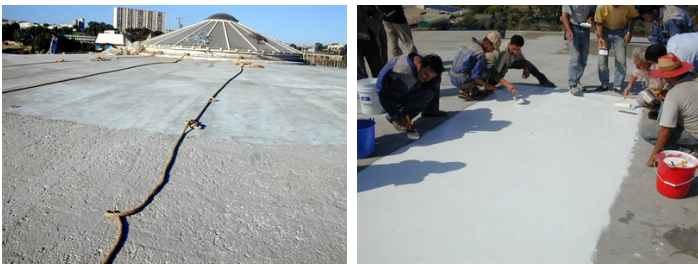
Corrosion and weather damage had caused the 12,000m² roof of the Olympic Complex to leak.

* Damaged concrete roof Application of Belzona® 3111 Completed application in 2003 Revisited application in 2014 ,

Application was carried out in accordance with Belzona Know-How System Leaflet RPA-1. Firstly the asbestos coating inside the dome was removed. The roof was resurfaced using a cement based screed to provide a good base for the new coating. A fully reinforced Belzona® 3111 system was then applied.

The Application was revisited in 2009. After 6 years in service, there was no deterioration of the roof structure. The coating, although covered in dust following a dust storm, was still in an excellent condition underneath. The coating still provided UV-resistance and was watertight.
