LIVE LEAK SEALING WITH BELZONA

ID: 2691

Application: VPF-Valves, Pipes and Fittings

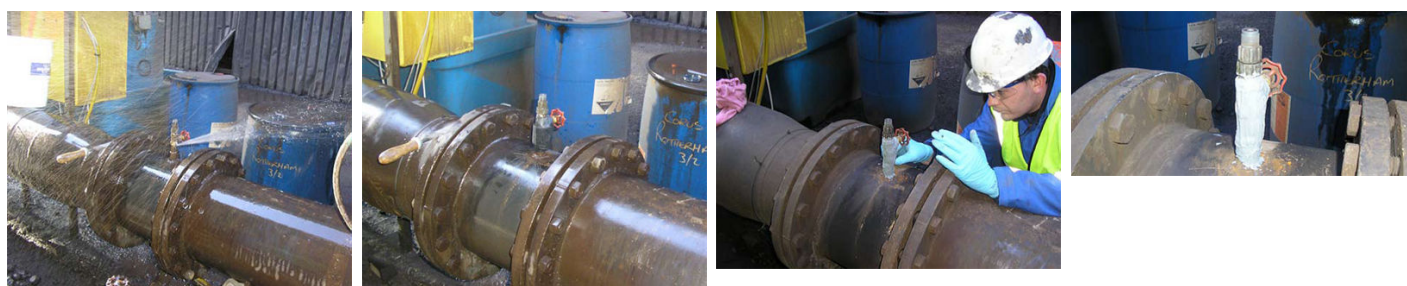
Photograph Descriptions

- * Severe leak ,
- * Leak plugged with Belzona® 1291 ,
- * Attention to detail during application of Belzona® 1161 ,
- * Finished application ,

Leaking cooling water pipe.

Application was carried out in accordance to Belzona Know-How System Leaflet VPF-11. Temporary seal effected with Belzona® 1291 before reinforcing with Belzona 1161 to create more permanent seal.
