# LIVE LEAK SEALING WITH BELZONA

ID: 2691

**Application:** VPF-Valves, Pipes and Fittings

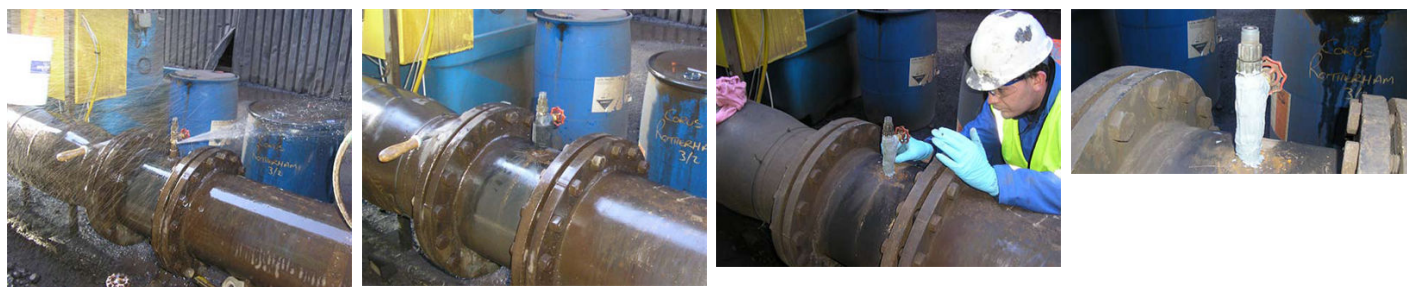
- \* Severe leak ,
- \* Leak plugged with Belzona® 1291 ,
- \* Attention to detail during application of Belzona® 1161 ,
- \* Finished application ,

Leaking cooling water pipe.

Application was carried out in accordance to Belzona Know-How System Leaflet VPF-11. Temporary seal effected with Belzona® 1291 before reinforcing with Belzona 1161 to create more permanent seal.

To shut down the pipe line for a traditional repair could cost the company up to £60,000 per hour. Belzona were able to offer a very cost effective live leak repair. The repair, visited 3 years on was showing no sign of deterioration.
