BELZONA REPAIRS SUBWAY HANDRAIL

ID: 27

Handrail of escalator at a subway station

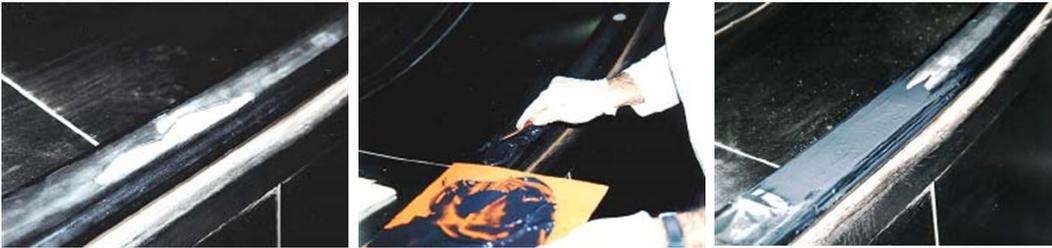
Photograph Descriptions

Due to vandalism, a chunk of rubber was missing from the handrail.

- * The damage due to the vandalism ,
- * Application of Belzona® 2311 (SR-Elastomer) in progress ,
- * The finished repair ready for operation ,

The application was carried out in accordance with a modified version of Belzona Know-How Leaflet SHM-1.

The repair was completed with \$50.00 of Belzona product. The alternative was hot vulcanizing which would have shut the escalator down for one day and cost approximately \$2,000. The repair took only two hours to perform, and after three years, is still in operation today.
