# BELZONA REPAIRS SUBWAY HANDRAIL

Customer Location: Subway Station in Quebec, Canada

Handrail of escalator at a subway station

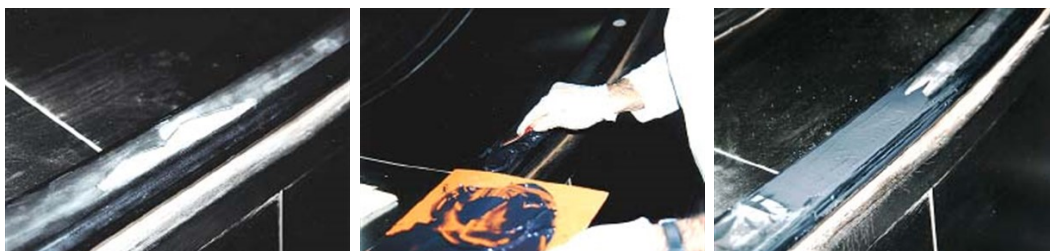
Due to vandalism, a chunk of rubber was missing from the handrail.

- \* The damage due to the vandalism ,
- \* Application of Belzona® 2311 (SR-Elastomer) in progress ,
- \* The finished repair ready for operation ,

The application was carried out in accordance with a modified version of Belzona Know-How Leaflet SHM-1.

The repair was completed with \$50.00 of Belzona product. The alternative was hot vulcanizing which would have shut the escalator down for one day and cost approximately \$2,000. The repair took only two hours to perform, and after three years, is still in operation today.
