BELZONA PROTECTS HOT PIPEWORK

ID: 2710

Customer Location: Refinery, Germany
Application Date: September 2010

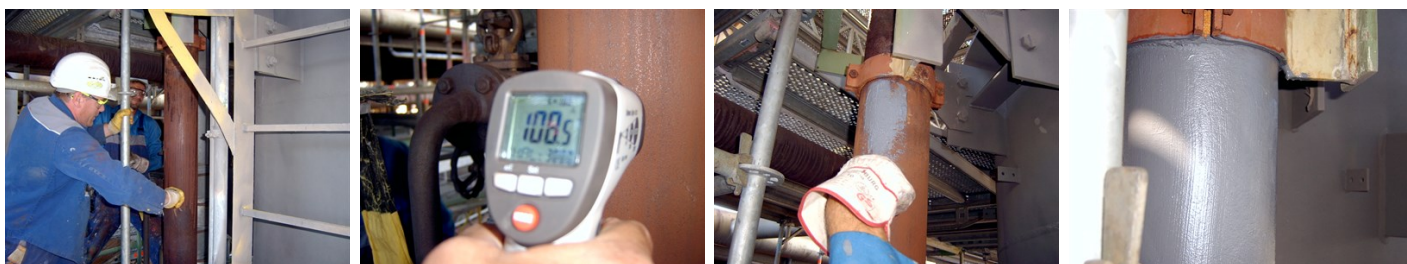
Photograph Descriptions

Original paint system was failing allowing pipework to corrode. New protection required to be applied whilst system remained operational.

- * Surface preparation underway ,
- * Temperature reading of the hot pipe ,
- * Application of coating ,
- * Finished application ,

Application was carried out in accordance with Belzona System Leaflet TCC-5. As the pipe was in hot service only minimal surface preparation could be carried out to remove the existing coating. Once the pipe was returned to a sound substrate, the product was applied by brush to the hot pipework.
