# BELZONA PROVES TO BE THE MATERIAL FOR CHEMICAL CONTAINMENT AREAS

ID: 272

Application: *TCC-Tanks and Chemical Containment Areas*

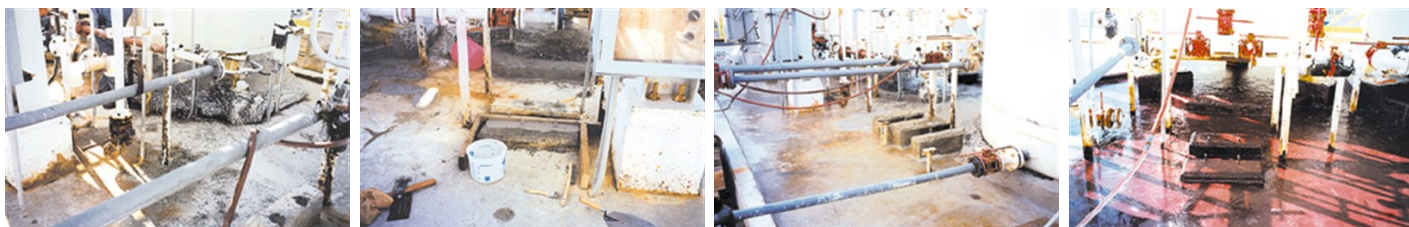
## Photograph Descriptions

*Repetitive exposure to concentrated hydrochloric and hydrofluoric acids, which eroded the concrete substrate.*

- \* The area has been cleaned/degreased Belzona® 4131 is being used to rebuild the eroded areas ,
- \* Belzona® 4911 has been applied prior to the final coating ,
- \* The completed application. ,

At least five imitation products had failed to protect the containment area prior to Belzona. Belzona® 4131 was used to rebuild the eroded areas, and Belzona® 4311 was used to coat the entire containment area.
