BELZONA RETURNS THIS 20-YEAR-OLD PUMP TO LIKE NEW CONDITION

Customer Location: Electrical utility plant in San Antonio, Texas U.S.A.

Application: CEP-Centrifugal Pumps

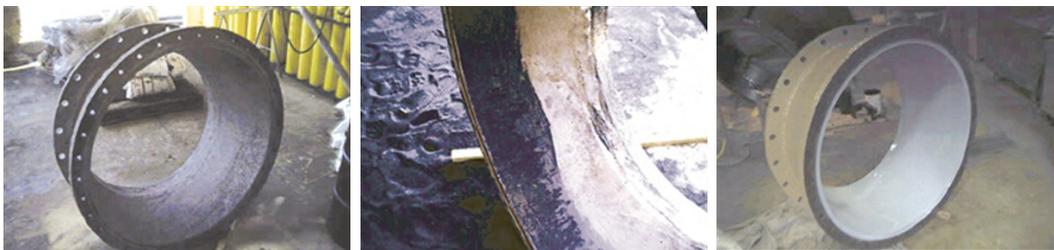
The pump was heavily scaled and had significant corrosion.

- * The pump diffuser connecting piece prior to the application ,
- * Blasted with Belzona® 1111 applied ,
- * The pump piece has been coated with Belzona® 1341 ,

The pump was grit blasted and cleaned. Belzona® 1341 was applied to the pump volute, impeller and the inside surfaces of the flow diffuser. Belzona® 5811 was applied to the outside of the volute, the diffuser and the connecting pieces after which Belzona® 1111 was used to rebuild the worn areas on the diffuser and connecting pieces.
