BELZONA THWARTS BLOWER FAN CORROSION

ID: 275

Industry: *General Industry*
Application: *FBC-Fans, Blowers and Compressors*

52" diameter blower fan

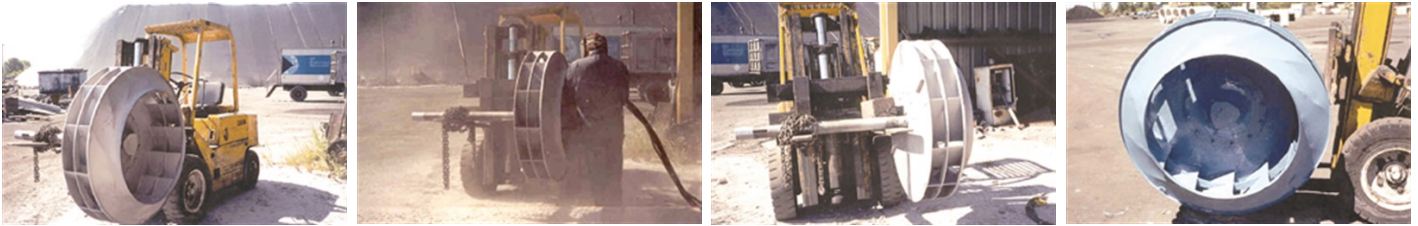
Photograph Descriptions

The high moisture environment the fan was operating led to corrosion. In addition, by-product was accumulating on the surface, putting the fan out of balance.

- * The fan prior to the application ,
- * Fan undergoing surface preparation by grit blasting ,
- * The surface preparation has been completed ,
- * The fan has been coated with Belzona ® 1341 and is ready to be put back into service ,

The application was carried out in accordance with Belzona Know-How System Leaflet FBC-2.
