# BELZONA THWARTS BLOWER FAN CORROSION

ID: 275

Industry: *General Industry*  
Application: *FBC-Fans, Blowers and Compressors*

Customer Location: *Shipping company in Canada*  
Application Date: *August 2001*

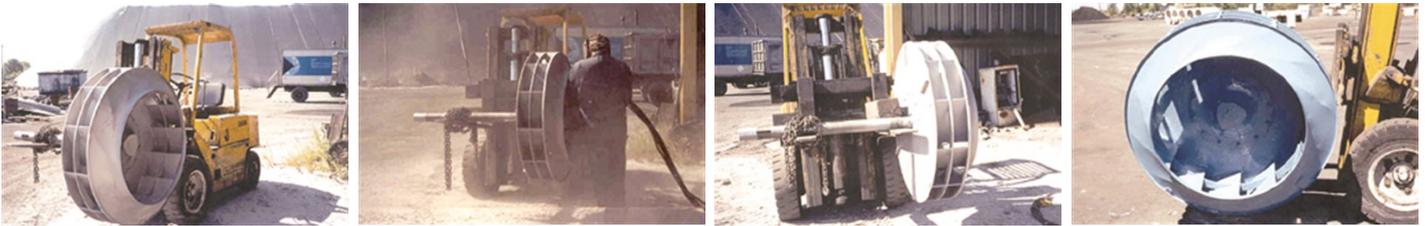
*The high moisture environment the fan was operating led to corrosion. In addition, by-product was accumulating on the surface, putting the fan out of balance.*

- \* The fan prior to the application ,
- \* Fan undergoing surface preparation by grit blasting ,
- \* The surface preparation has been completed ,
- \* The fan has been coated with Belzona ® 1341 and is ready to be put back into service ,

The application was carried out in accordance with Belzona Know-How System Leaflet FBC-2.
