Belzona Restores Safety to Fire Escape Stairway

ID: 2777

Customer Location: Water Supplier, UK
Application Date: April 2011

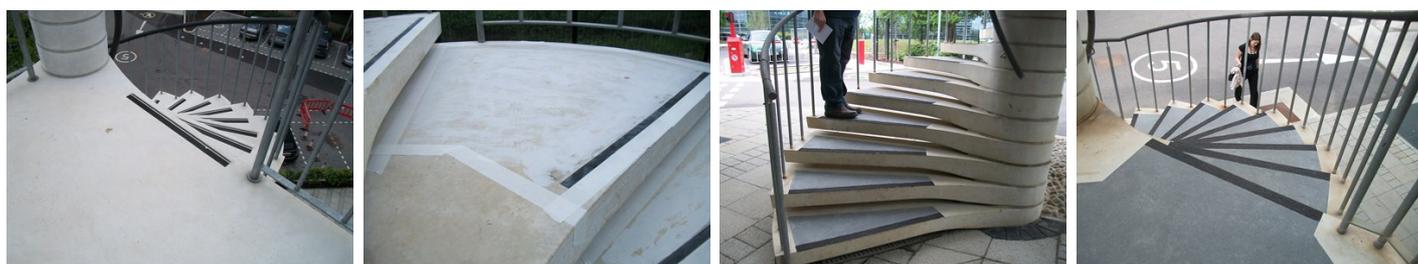
Photograph Descriptions

The concrete steps had worn and the current safety grip system had become almost none existent due to heavy foot traffic and weathering. A member of staff had slipped down the steps and injured themselves so solution to this serious slip hazard required.

- * Staircase prior to application ,
- * Surface prepared ready of application ,
- * Completed Application ,
- * Completed Application ,

Smooth concrete fire escape stairway

The application was carried out in accordance with Belzona Know-How System Leaflet FPA-8. Belzona® 4411 in grey was applied to the steps with Belzona® 9221 (Surefoot White Aggregate) incorporated into the main step areas and Belzona 9231 (Surefoot Aggregate) incorporated into the coating on the nosings.

The client was looking for a quick solution to overcome this safety issue and selected the Belzona solution as Belzona system offered not only a quick but also long term solution. The application was completed within 3 weeks with minimal disruption to employees and is now providing a safe well gripped fire escape.
