BELZONA REPAIR ON STEEL MILL

ID: 2786

Customer Location: *Steel mill, Spain*
Application Date: *2009*

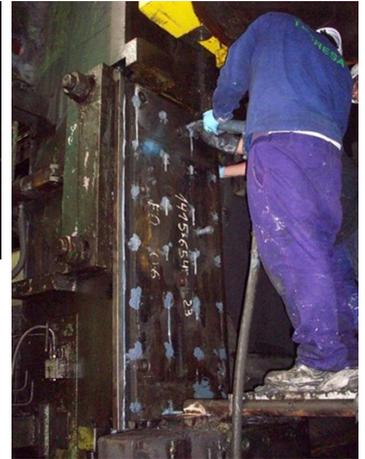
In the rolling mill housing there were several wear plates which guide the hot steel slabs. Impact and vibration from the heavy metal slabs create damage to the housing behind the wear plates. A significant gap occurred between the support and plates leading to misalignment.

- * Mill Housings ,
- * Applying Release Agent to underside of wear plates ,
- * Injection Holes ,
- * Finishing off the injection of Belzona® 1321 ,

Due to impact, the soft steel behind the steel guide wear plates in the steel production line were damaged.

Application carried out in accordance with Belzona Know-How System Leaflet GSS-9. After cleaning and treating the wear plates with Belzona® 9411 (Release Agent), the plates were aligned by experts before the Belzona® 1321 was injected to fill void between wear plate and housing.

Before the repair with Belzona, a new stainless steel plate had to be installed every month. After the Belzona repair, no movement has been detected in the repaired housing after 5 months and the wear plates were still in their ideal position. The mill's downtime has been dramatically reduced.
