# BELZONA SEALS LEAKS ON SUPERGRID TRANSFORMER

ID: 2787

Customer Location: UK  
Application Date: April 2011

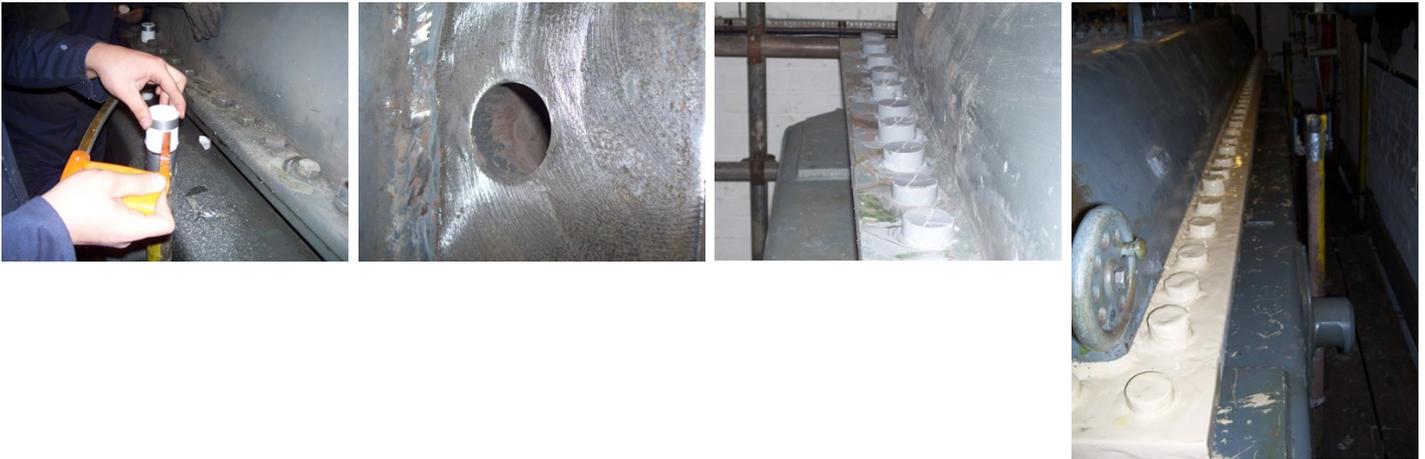
The transformer was leaking through the bolt holes along the flange face.

- \* PVC pipe being cut into sections to cover bolts ,
- \* Surface preparation using MBX Bristle Blaster ,
- \* The Belzona® 1161 encapsulated bolts ,
- \* Completed application with Belzona® 5831 applied ,

Application was carried out using a modified version of Belzona Know-How System Leaflet VPF-11a. after preparing the metal with an MBX Bristle Blaster, Belzona® 1161 was then used to seal the bolts using PVC pipe of a wider diameter placed over the bolts and filled with the Belzona until totally encapsulated. Once cured, The PVC cups were cut away so that the entire flange could then be covered with Belzona® 5831 to provide overall corrosion protection.

The application was a success and has been in service for over 8 months now with no signs of leakage, leading to further business with the same client on more of their assets.
