# BELZONA RESTORES BEARING HOUSING TO LIKE-NEW CONDITION

Industry: *Pulp & Paper*  
Application: *MPT-Mechanical Power Transmission*

Customer Location: *Paper Mill in Japan*  
Application Date: *1997*

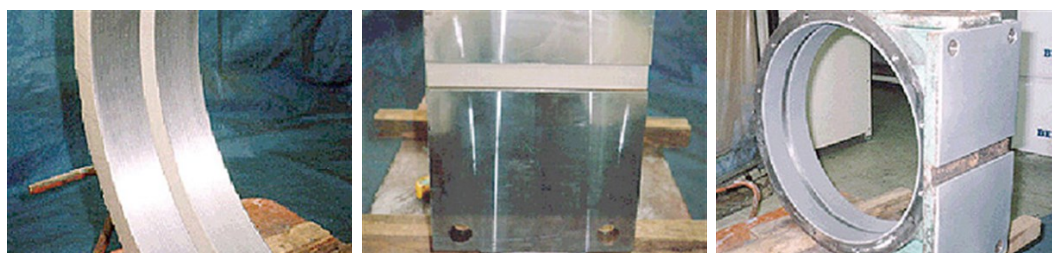
*This winder bearing housing suffered mechanical damage from vibration, foreign substances and irregular rotational motion.*

- \* Surface preparation of bearing housing ,
- \* View of damaged flange mounting ,
- \* The bearing housing is ready for service ,

The application was carried out in accordance with Belzona Know-How System Leaflet MPT-6. Applied by hand and machined to tolerances.

Belzona® 1111 (Super Metal) was machined to form a perfect cylindrical bearing surface while maintaining the lubrication seal. The flange mounting was also rebuilt and machined for a secure mating surface to the paper machine framework. The winder section of the paper machine must run continuously and reliably in order for the mill to remain profitable.
