BELZONA EXTENDS THE LIFE OF THIS TRUNION END BEARING

ID: 281

Industry: *Pulp & Paper*
Application: *MPT-Mechanical Power Transmission*

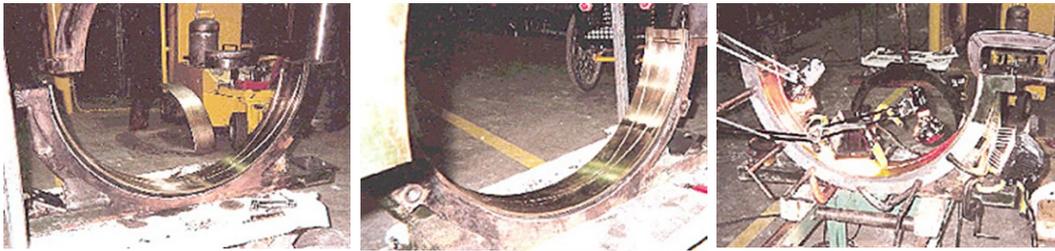
The lubrication system failed on the trunion end bearing on a 4-ton lime kiln, wearing through the entire bronze liner and into the cast iron pillow block.

- * Pillow block damage evident ,
- * Trial fit of new bronze liner ,
- * Rebuilt cast iron using a forming technique ,

The application was carried out in accordance with Belzona Know-How System Leaflet MPT-7. Side shields, C-clamps and infrared lights were used to speed up the cure time.

The cost of a new cast iron trunion is approximately \$20,000. Replacement of a new trunion was considered, but weeks of procurement time eliminated that possibility because the lime kiln was shut down. The pro-file was restored by using Belzona® 1111 (Super Metal).
