# BELZONA SIMPLIFIES CONVEYOR BELT REPAIRS

ID: 2827

Customer Location: *Newspaper Distribution Centre, South East, UK*

Application: *SHM-Solids Handling Machinery*

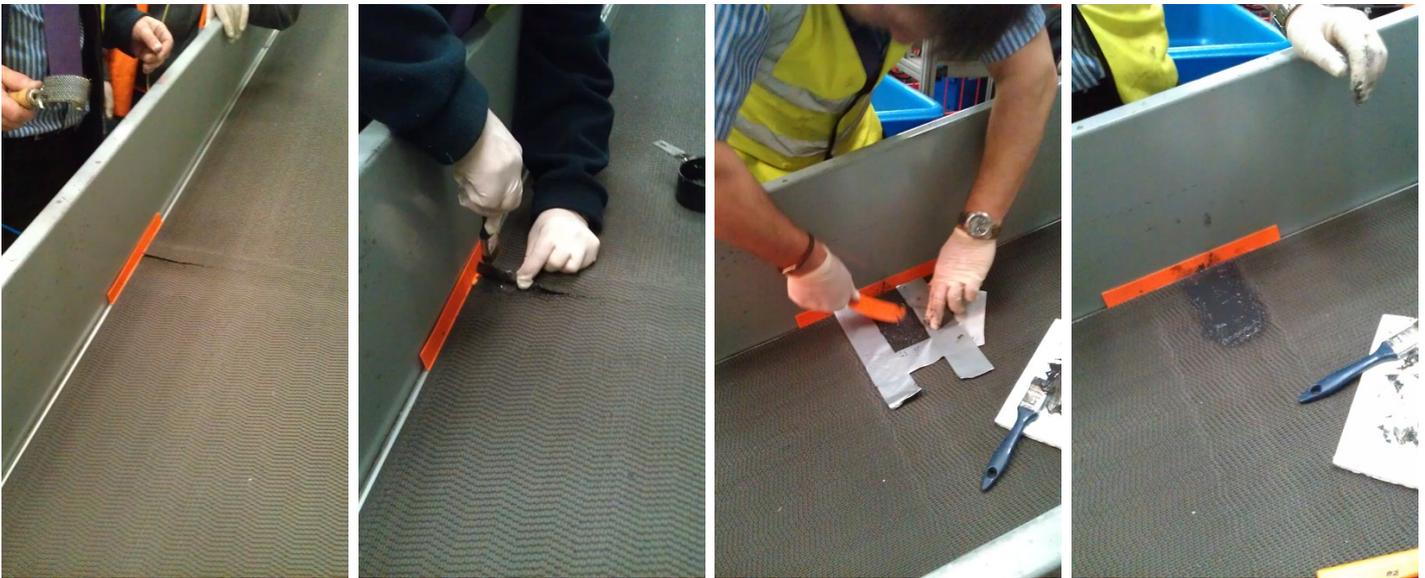
*From time to time the conveyor belt will get damaged from the papers or magazines getting jammed up between the side walls and the rollers.*

- \* Roughing up the damaged surface ,
- \* Applying the Belzona Elastomer Conditioner ,
- \* Application of Belzona® 2311 to the masked area ,
- \* Completed application with Belzona Reinforcement tape embedded in the repair and ready to go back in service ,

Application was carried out in accordance with Belzona Know-How System Leaflet SHM-1. The conveyor belt was stopped once the shift had finished and can be repaired before the next start-up.
