BELZONA KEEPS THIS SPLINE ON THE STRAIGHT AND NARROW

ID: 284

Planetary gear spline for mandril mill manufacturing pipe.

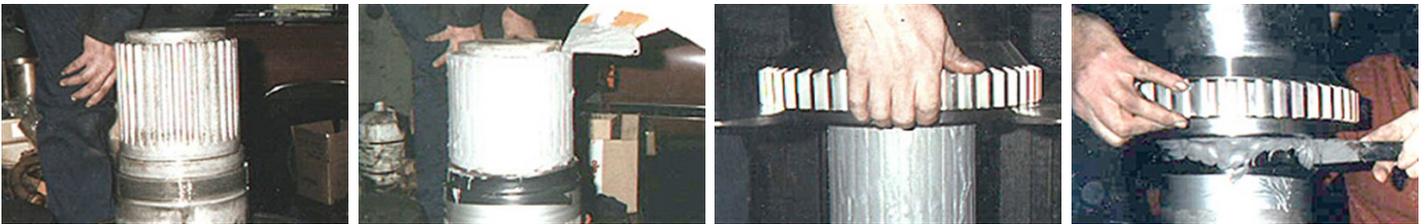
Photograph Descriptions

Wear of the shaft spline due to abrasive contamination as well as misalignment caused excess slop in the drive and eventual failure of the mandril unit.

- * The equipment prior to the application ,
- * Belzona® 1111 is being applied to the spline ,
- * The spline and socket are being mated ,
- * Excess material is being removed ,

The application was carried out in accordance with Belzona Know-How System Leaflet MPT-5. Belzona® 9411 (Release Agent) was applied to the socket and Belzona® 1111 (Super Metal) was applied to both the socket and spline before mating the two pieces.

The spline was in perfect condition 5 years later when the mill finally decided to replace the spline coupling.
