# EXTENDED DOWN TIME AVERTED BY USING BELZONA

ID: 286

Industry: General Industry  
Application: MPT-Mechanical Power Transmission

Customer Location: Steel manufacturer in Alabama, USA  
Application Date: 1995

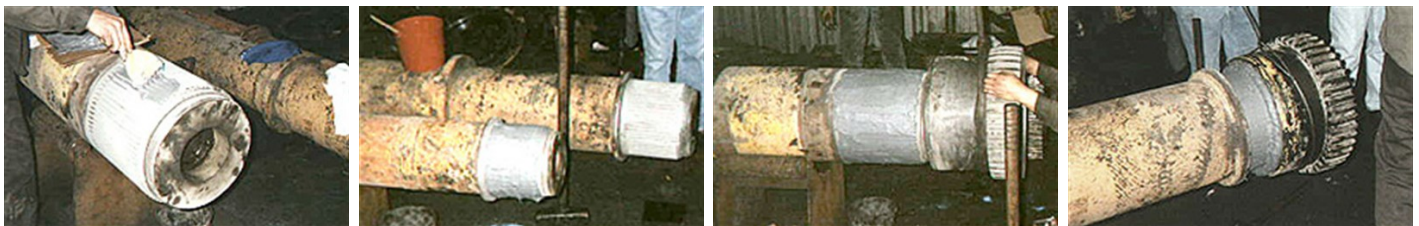
*Excess tolerances in the spline caused problems with the smooth trans-mission of force to the mandril for pipe manufacture.*

- \* Application of Belzona® 1121 to spline ,
- \* Liberal amounts of Belzona® 1121 to spline ,
- \* The gear is being fitted onto the spline ,
- \* Final location of gear alignment ,

The application was carried out in accordance with Belzona Know-How System Leaflet MPT-5. Belzona® 9411 (Release Agent) was applied to the gear, and Belzona® 1121 (Super XL-Metal) was liberally applied to the spline and gear before mating.
