# BELZONA NON-SKID SYSTEM REMOVES SLIP AND FALL HAZARD

ID: 289

**Customer Location:** Hospital in British Columbia, Canada  
**Application Date:** 1997

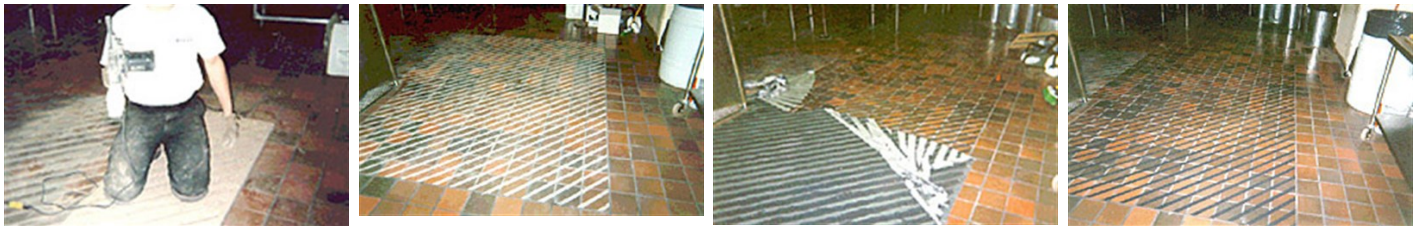
## Photograph Descriptions

- \* Surface preparation with template ,
- \* Glaze removed from quarry tile floor ,
- \* Masking tape removed after the application is complete ,
- \* Completed application of grip system ,

Quarry tiled floor in a hospital dish washing area.

The application was carried out in accordance with Belzona Know-How System Leaflet FPA-8.

It was found that the Belzona system initially cost about 30% more, but eliminated the need for replacement pads. The application has been in service for 5 years with no required maintenance.
