BELZONA FOR THE REPAIR OF STEP NOSINGS

ID: 290

Customer Location: Furniture manufacturer in North Carolina U.S.A.

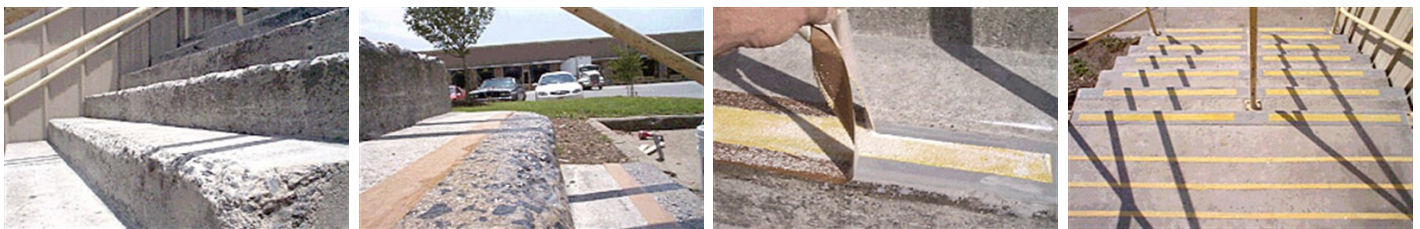
Photograph Descriptions

The step nosings leading to a loading area became rounded from constant traffic and improper handtruck usage.

- * Damage to step nosings ,
- * Belzona® 4911 (TX Conditioner) applied to steps ,
- * Peeling tape off to reveal Belzona® 4411 (Granogrip) ,
- * Completed application ,

The application was carried out in accordance with Belzona Know-How System Leaflet FPA-8.

The leading edges of steps take a tremendous beating, and the Belzona material has a combination of adhesive as well as the compressive strength in order to provide a long lasting solution.
