# BELZONA KEEPS ENTRANCE WAY STEPS LOOKING GOOD AND SAFE

ID: 292

Customer Location: Agency building - Houston, Texas U.S.A.

Application Date: April 1985

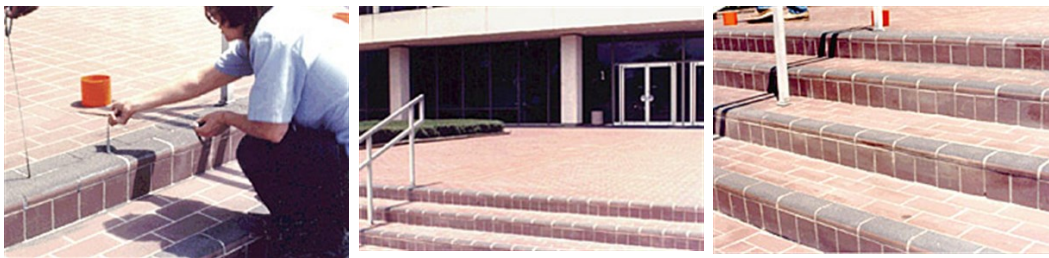
Various non-skid materials had previously been applied to the nosings of these quarry tile steps with no long-term success.

- \* Pulling the tape while the Belzona® 4411 is still wet ,
- \* View of entire area ,
- \* Close-up view of completed application ,

Belzona® 4411 (Granogrip) was applied by brush in conjunction with Belzona® 9221 (Surefoot Aggregate) on the nosings of the quarry tile steps. 1/4 inch tape was cut and placed over the grout lines of the tile to simulate the quarry tile appearance. This area is high visibility for visiting dignitaries and tourists, so emphasis was placed on safety and cosmetics.
