BELZONA EMERGENCY PIPE REPAIR AT SCHOOL

ID: 2927

Application: VPF-Valves, Pipes and Fittings

Substrate: Steel Pipe

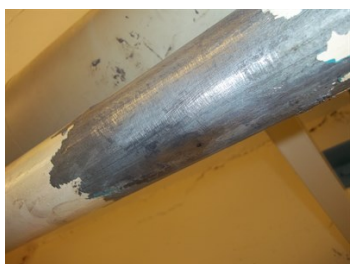
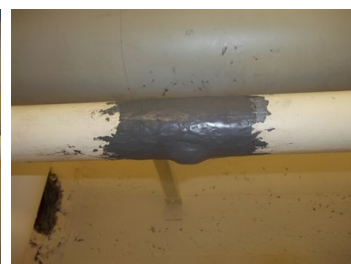
Photograph Descriptions

Two small pin holes had appeared under the paint in the main water pipe. Water was now leaking onto the floor creating a slip hazard over a large area.

- * Surface preparation ,
- * Application of Belzona® 1291 to stem the leak ,
- * Belzona® 1291 being held in place with tourniquet during cure ,
- * Belzona® 1221 applied with Belzona® 9341 (Reinforcement tape) over the Belzona® 1291 to complete the repair ,

Application was carried out in accordance with Belzona Know-How System Leaflet VPF-11

The mains water pipe could only shut down for a short period of time as it supplied the kitchens and the toilet block, a very fast repair was required. The repair was carried out within an hour with no disruption to the school or pupils.
