BELZONA EMERGENCY PIPE REPAIR AT SCHOOL

ID: 2927

Application: VPF-Valves, Pipes and Fittings

Water pipe in a school boiler room

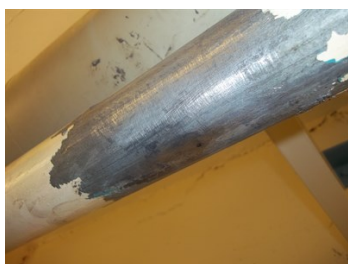
Two small pin holes had appeared under the paint in the main water pipe. Water was now leaking onto the floor creating a slip hazard over a large area.

- * Surface preparation ,
- * Application of Belzona® 1291 to stem the leak ,
- * Belzona® 1291 being held in place with tourniquet during cure ,
- * Belzona® 1221 applied with Belzona® 9341 (Reinforcement tape) over the Belzona® 1291 to complete the repair ,

Application was carried out in accordance with Belzona Know-How System Leaflet VPF-11
