# BELZONA SUCCESSFULLY REFURBISHES SCHOOL STEPS

Industry: Buildings & Structures  
Application: FPA-Floor Problem Areas  
Substrate: Concrete  
Products: \* Belzona 5811 (Immersion Grade) ,  
\* Belzona 4411 (Granogrip) ,

Customer Location: Warwickshire, UK  
Application Date: May 2011

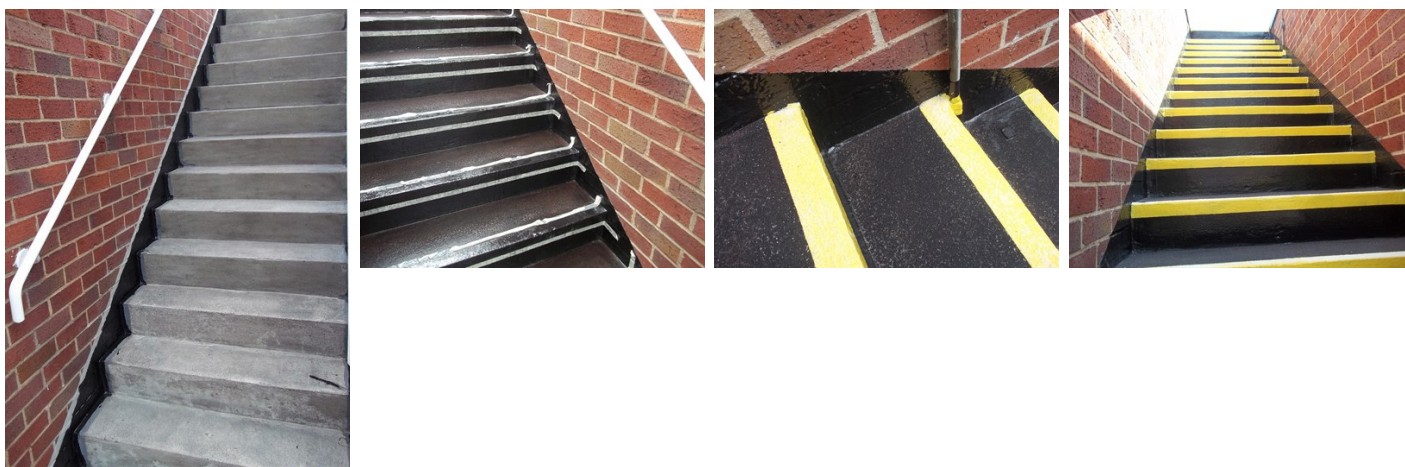
Steps were leaking into a wash room below so needed to be sealed. Also access to the roof was needed so slip hazards had become an issue.

- \* 1. Application of Belzona 5811 to walls. ,
- \* 2. Application of Belzona 5811 to steps. ,
- \* 3. Complete encapsulation of steps and walls. ,
- \* 4. Completed application with Belzona 4411 on step noses. ,

Application was carried out in accordance with Belzona Know How System Leaflet FPA-8

Repairs were carried out over two days and have now provided the school with waterproof and safe steps. They were so pleased with the results that they had other sets of steps coated with Belzona 4411.
