BELZONA SUCCESSFULLY REFURBISHES SCHOOL STEPS

ID: 2928

Industry: Buildings & Structures
Application: FPA-Floor Problem Areas
Substrate: Concrete
Products: * Belzona 5811 (Immersion Grade) ,
* Belzona 4411 (Granogrip) ,

Customer Location: Warwickshire, UK
Application Date: May 2011

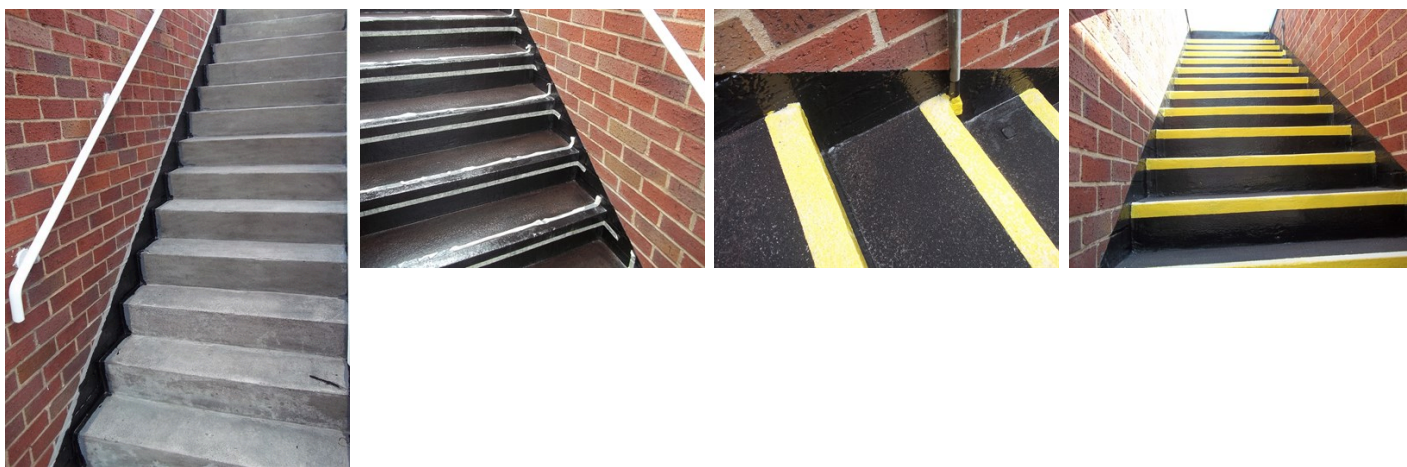
- * 1. Application of Belzona 5811 to walls. ,
- * 2. Application of Belzona 5811 to steps. ,
- * 3. Complete encapsulation of steps and walls. ,
- * 4. Completed application with Belzona 4411 on step noses. ,

Steps were leaking into a wash room below so needed to be sealed. Also access to the roof was needed so slip hazards had become an issue.

Application was carried out in accordance with Belzona Know How System Leaflet FPA-8

Repairs were carried out over two days and have now provided the school with waterproof and safe steps. They were so pleased with the results that they had other sets of steps coated with Belzona 4411.
