# BELZONA REFURBISHES SCHOOL STEPS

Industry: Buildings & Structures  
Application: FPA-Floor Problem Areas  
Substrate: Concrete  
Products: \* Belzona® 5811 (Immersion Grade) ,  
\* Belzona® 4411 (Granogrip) ,

Customer Location: Warwickshire, UK  
Application Date: May 2011

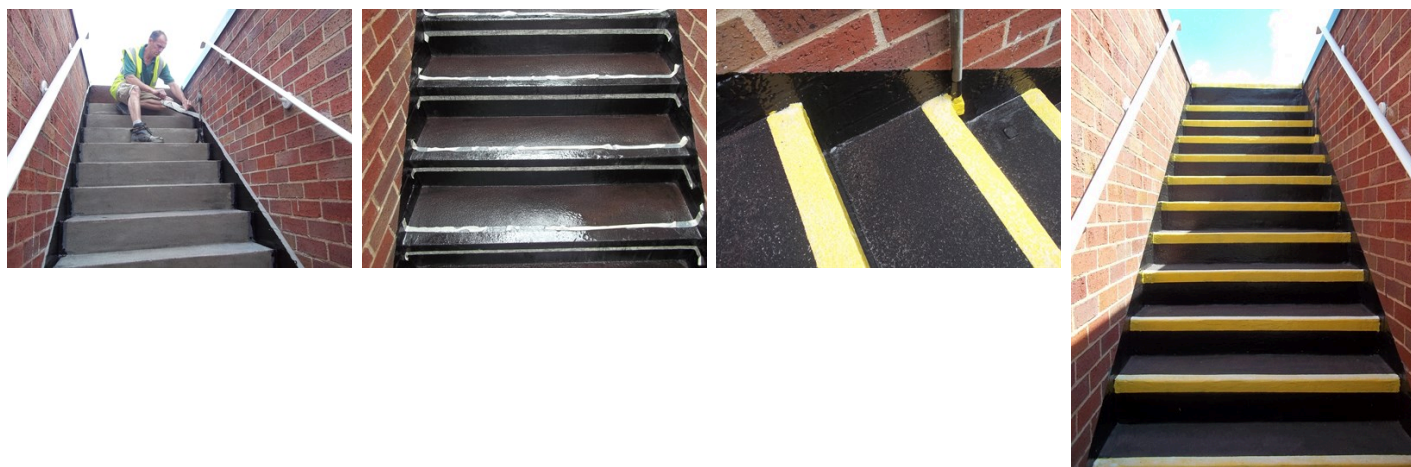
Steps were allowing water into the wash room below so needed to be sealed. Also access to the roof was needed so elimination of any slip hazards had become an issue.

- \* Application of Belzona® 5811 to walls ,
- \* Application of Belzona® 5811 to steps ,
- \* Complete encapsulation of steps and wall ,
- \* Completed application with Belzona® 4411 on step noses ,

Repairs were carried out over two days and have now provided the school with safe and waterproof steps. Following the success of this repair, the customer has since treated several other steps on the site with Belzona 4411.
