BELZONA REPAIRS DAMAGED FLOOR AT CIDER PLANT

ID: 2931

Customer Location: Cider producer, Herefordshire, UK
Application Date: January 2012

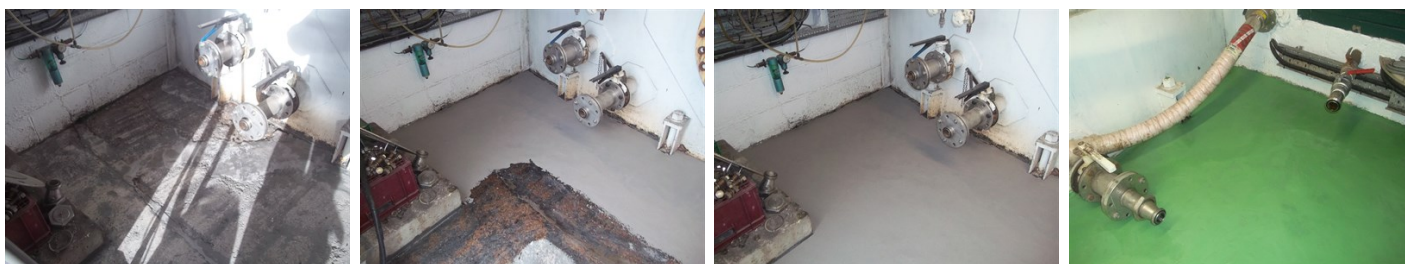
Photograph Descriptions

Due to spillage of cider concentrate the concrete floor had begun to break up and created health and safety issues with trips and slips.

- * Damaged floor ,
- * Application of Belzona® 4131 including conditioner to ensure maximum adhesion ,
- * Complete floor repaired with Belzona® 4131 ,
- * Application of Belzona® 5231 completed ,

Application was carried out in accordance with Belzona Know-How System Leaflet FPA-1. Belzona® 4131 used to repair damaged concrete and level surface before coating with Belzona 5231.

Both Belzona® 4131 and Belzona® 5231 have been used many times around the site to protect against the effects of the cider. Alternatives have been tried before but Belzona offers them the best long term solution. The Belzona system used enabled floor to be levelled and then finished with slip resistant hygienic surface.
