# BELZONA REPAIRS DAMAGED FLOOR AT CIDER PLANT

ID: 2931

**Customer Location:** Cider producer, Herefordshire, UK  
**Application Date:** January 2012

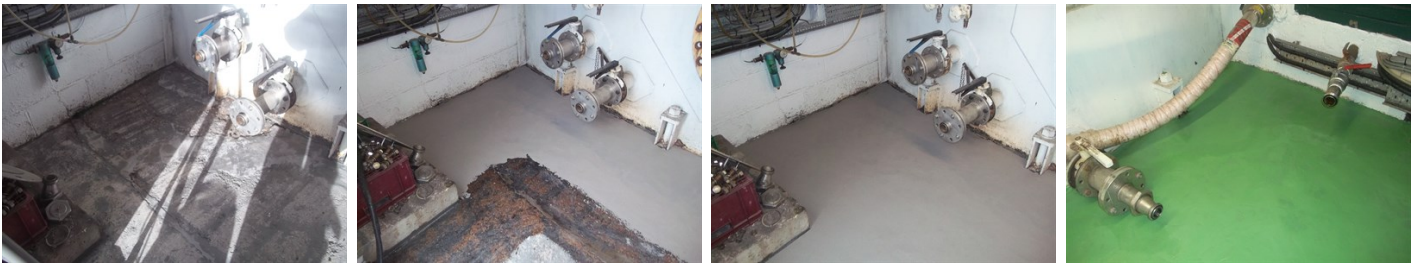
Due to spillage of cider concentrate the concrete floor had begun to break up and created health and safety issues with trips and slips.

- \* Damaged floor ,
- \* Application of Belzona® 4131 including conditioner to ensure maximum adhesion ,
- \* Complete floor repaired with Belzona® 4131 ,
- \* Application of Belzona® 5231 completed ,

Application was carried out in accordance with Belzona Know-How System Leaflet FPA-1. Belzona® 4131 used to repair damaged concrete and level surface before coating with Belzona 5231.
