# BELZONA REPAIRS DAMAGED FIRE ESCAPE STEPS AT SCHOOL

ID: 2933

Steel fire escape steps

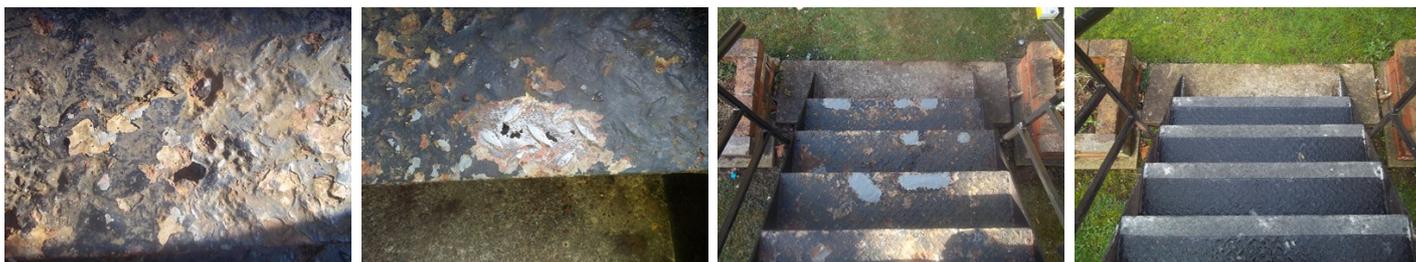
Due to age and weathering the steel plates had become holed and badly corroded creating a safety hazard.

- \* Corroded & holed steps ,
- \* Surface preparation ,
- \* Holed steps repaired with Belzona® 1111 ,
- \* Completed steps with Belzona® 5811 applied and nosings blinded with Surefoot Aggregate ,

Application was carried out in accordance with Belzona Know-How System Leaflet FPA-8. After surface preparation was carried out, the small holed areas were rebuilt with Belzona® 1111. The steps were then overcoated with Belzona® 5811 and Belzona® 9221 (Surefoot Aggregate) blinded into the step noses.
