BELZONA MAKES WALKWAY SAFE

ID: 2953

Customer Location: Cider producer, Herefordshire, UK
Application Date: September 2011

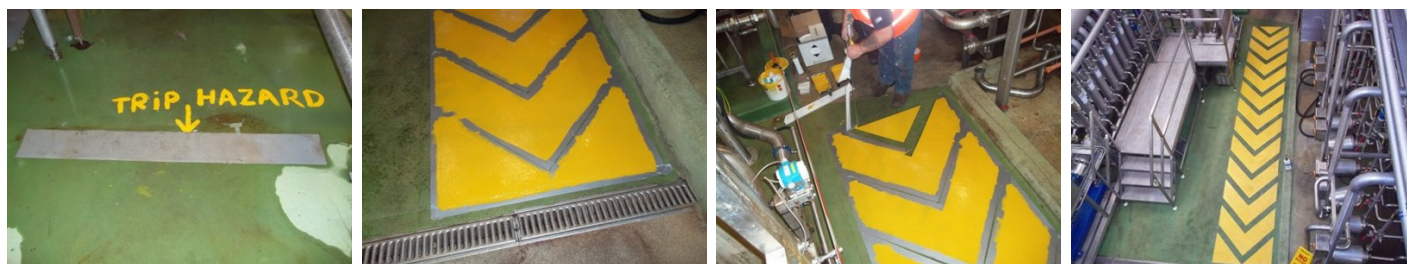
Photograph Descriptions

Delamination of resin floor had caused a trip hazard. When the repair was looked at they noted that there was a slip hazard in the same area.

- * Trip hazard levelled with Belzona® 4131 ,
- * Application of Belzona® 4411 ,
- * Removal of masking tape ,
- * Completed application. ,

Application was carried out in accordance with Belzona Know-How System Leaflet FPA-8. Belzona® 4131 applied to level floor area before applying Belzona® 4411 grip system.

When routine maintenance was carried out they would step out of a small bund with wet feet. Belzona® 4131 ability to be feather edged allowed easy levelling of the walkway. The yellow Belzona® 4411 was chosen as both a positive grip system and as a visual aid.
