BELZONA REPAIRS DAMAGED CONCRETE AT CIDER PLANT

ID: 2955

Customer Location: Cider producer, Herefordshire, UK

Application Date: August 2011

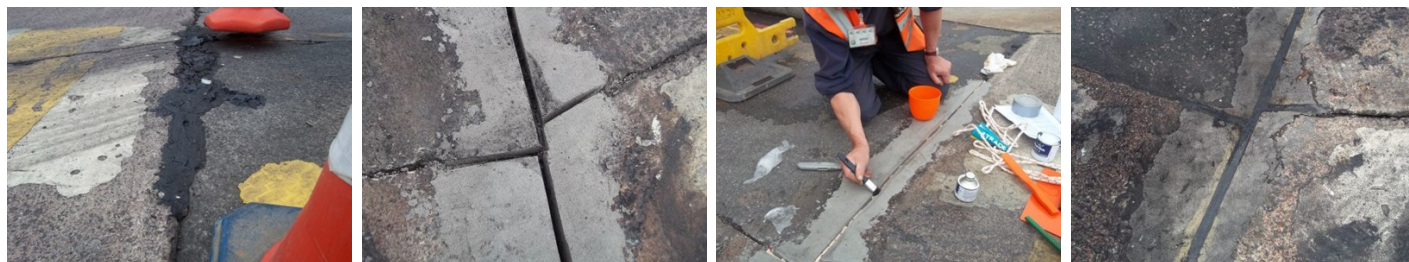
Photograph Descriptions

Damaged concrete on walkway was identified as a trip hazard.

* Previous attempted repair Nosings rebuilt with Belzona® 4131 Application of Belzona Elastomer Conditioner Completed application with joint sealed using Belzona® 2211 ,

Application was carried out in accordance with Belzona Know-How System Leaflet FPA-5 & 6. Damaged joint nosings were reformed with Belzona® 4131 before sealing joint with Belzona® 2211.

Other cheaper products had been used to try and fix problem but with no success. Belzona was chosen due to its proven reliability and longevity at other applications around the site. Belzona 4131 provides an impact resistant joint nosing whilst Belzona® 2211 provides strongly bonded highly elastic joint sealant.
