OFFSHORE FLOATING HOSES REPAIRED AND PROTECTED WITH BELZONA

ID: 2959

Customer Location: North Sea, UK
Application Date: June 2011

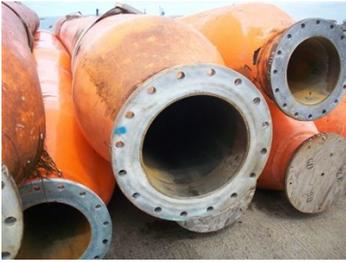
Corrosion pitting damage on flange faces caused by crevice corrosion posed a severe environmental hazard.

- * Tanker hoses awaiting repair ,
- * Belzona® 1321 coating inside the hose ,
- * Completed flange face reform ,
- * Internal coating on spool ,

Application was carried out in accordance with Belzona Know-How System Leaflets VPF-2 & 13. A prefabricated aluminium former was used to create new flange face surface with Belzona® 1321 including gramophone thread finish. A protective coating of Belzona® 1321 was applied inside the spool to offer protection against erosion-corrosion.
