BELZONA HEALS HOSPITAL EXPANSION JOINTS

Industry: General Industry
Application: FPA-Floor Problem Areas
Substrate: Concrete
Products: * Belzona® 4131 (Magma Screed) ,
* Belzona® 4411 (Granogrip) ,
* Belzona® 2211 (MP Hi-Build) ,

Customer Location: Hospital in North Carolina, U.S.A.
Application Date: July 1993

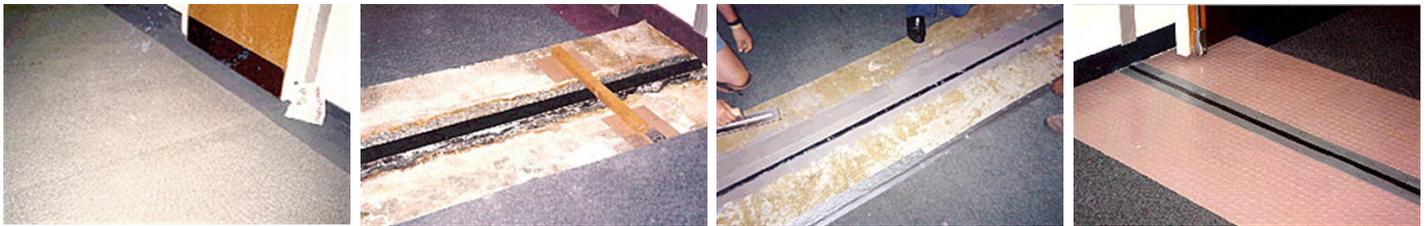
Photograph Descriptions

Deteriorated expansion joints cause problems with x-ray equipment as well as with individuals tripping throughout the hallways.

- * Joint indentation evident through carpet ,
- * Concrete nosings spalled from traffic ,
- * Nosing rebuilt and joint sealed ,
- * Completed application ready for traffic ,

The application was carried out in accordance with Belzona Know-How System Leaflets FPA-5 and FPA-6.
