BELZONA REFURBISHES SCHOOL ROOF

Industry: *Buildings & Structures*
Application: *RPA-Roof Problem Areas*
Substrate: *Ashfelt*

Customer Location: *Warwickshire, UK*
Application Date: *September 2011*

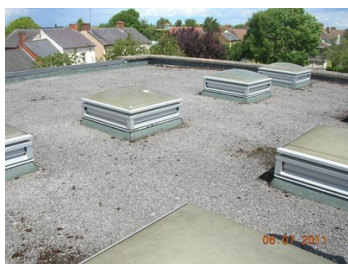
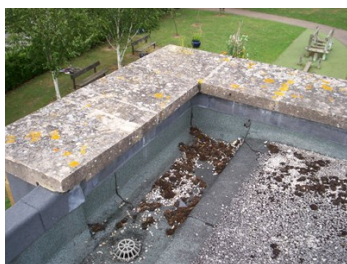
Due to age and cracks in both the parapit walls and in the ashfelt the roof was leaking into the classrooms below.

- * 1. and 2. Before Application ,
- * 3. and 4. After Application ,

Application was carried out in accordance with Belzona System Leaflet RPA-6 and RPA-10
