HOSPITAL KITCHEN REPAIRED WITH BELZONA

ID: 298

Customer Location: Hospital in North Carolina, U.S.A.
Application Date: Winter 2000

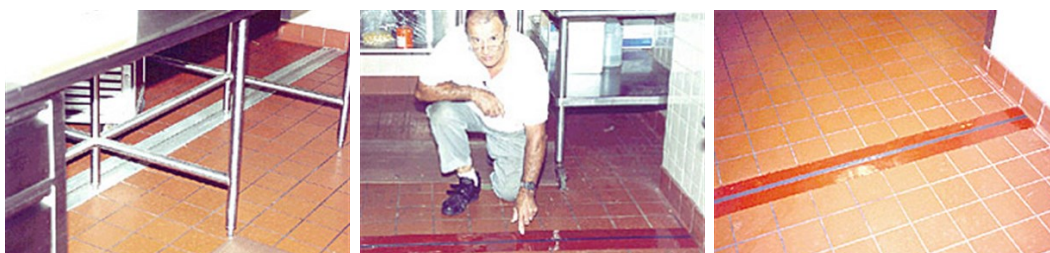
The metal expansion joint in the kitchen of this hospital had failed and the deterioration caused interruption in cart movement over the irregular sur-face.

- * Damaged metal expansion joint ,
- * Finished application with Belzona® 4151 recently applied ,
- * Nosing fully cured and ready for traffic ,

The application was carried out in accordance with Belzona Know-How System Leaflets FPA-5 and FPA-6.

The red Belzona® 4131 (Magma Screed) gives the repair area a close color match to the original quarry tile floor.
