BELZONA FOR MUD PUMPS

Customer Location: Offshore oil drilling platform in the Gulf of Mexico.

Application: CEP-Centrifugal Pumps

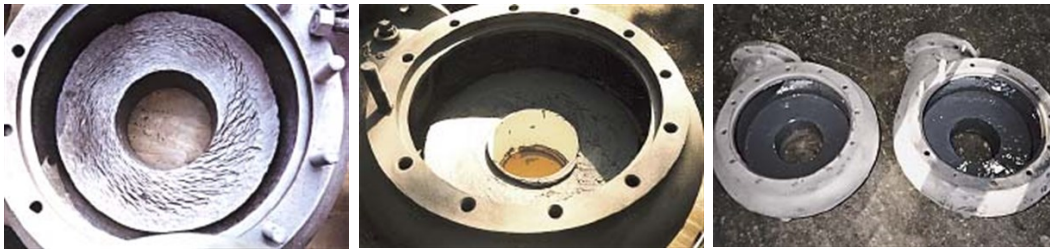
Photograph Descriptions

Severe erosion.

- * Severe wear on the pump casing. ,
- * Forming technique and Belzona® 1311 (Ceramic R-Metal) used to rebuild the intake. ,
- * Two coats of Belzona® 1321 (Ceramic S-Metal) applied. Several pumps have been refurbished. ,

The application was carried out in accordance with Belzona Know-How Leaflets CEP-3 and CEP-5.

The use of Belzona doubled the life of the casing and saved the replacement costs. Originally, the equipment lasted 3 months before being discarded and now it lasts 6 months and can be refurbished again and again.
