# BELZONA ROTARY WATER STRAINER WHEEL

ID: 30

Customer Location: Oil Refinery Power Station in Trinidad  
Application Date: December 1992

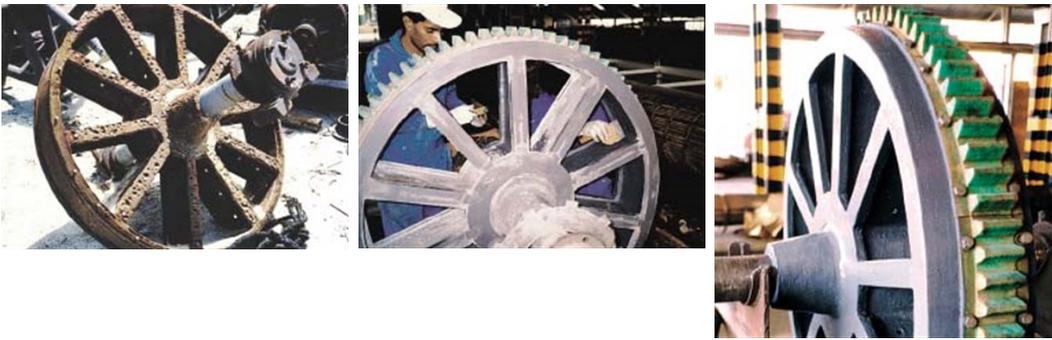
Extensive erosion/corrosion to the strainer wheel assembly which is in salt water service

- \* The wheel, note the extensive erosion/corrosion ,
- \* Application of Belzona® 1311 (Ceramic R-Metal) in progress ,
- \* Finished application with the gear assembly in place ,

Application was carried out in accordance with a modified version of Belzona Know-How Leaflets SOS-1 and SOS-2.

Belzona® 1341 (Supermetalgilde) was used to hold the blast, and formers were used to rebuild the vanes. The entire wheel was rebuilt with Belzona® 1311 (Ceramic R-Metal) and overcoated with Belzona® 1321 (Ceramic S-Metal). The application saved the operation of the plant since a replacement wheel was no longer available.
