BELZONA ROTARY WATER STRAINER WHEEL

Industry: Oil & Gas
Application: SOS-Ships and Offshore Structures

Customer Location: Oil Refinery Power Station in Trinidad
Application Date: December 1992

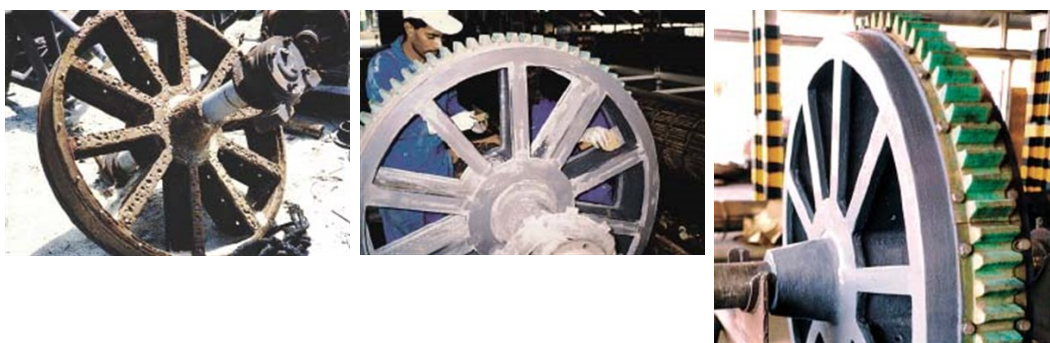
Photograph Descriptions

Extensive erosion/corrosion to the strainer wheel assembly which is in salt water service

- * The wheel, note the extensive erosion/corrosion ,
- * Application of Belzona® 1311 (Ceramic R-Metal) in progress ,
- * Finished application with the gear assembly in place ,

Application was carried out in accordance with a modified version of Belzona Know-How Leaflets SOS-1 and SOS-2.

Belzona® 1341 (Supermetalgilde) was used to hold the blast, and formers were used to rebuild the vanes. The entire wheel was rebuilt with Belzona® 1311 (Ceramic R-Metal) and overcoated with Belzona® 1321 (Ceramic S-Metal). The application saved the operation of the plant since a replacement wheel was no longer available.
