BELZONA SEALS LEAKING CAUSTIC TANK

ID: 3007

Customer Location: Drinks Manufacturer, North London
Application Date: November 2011

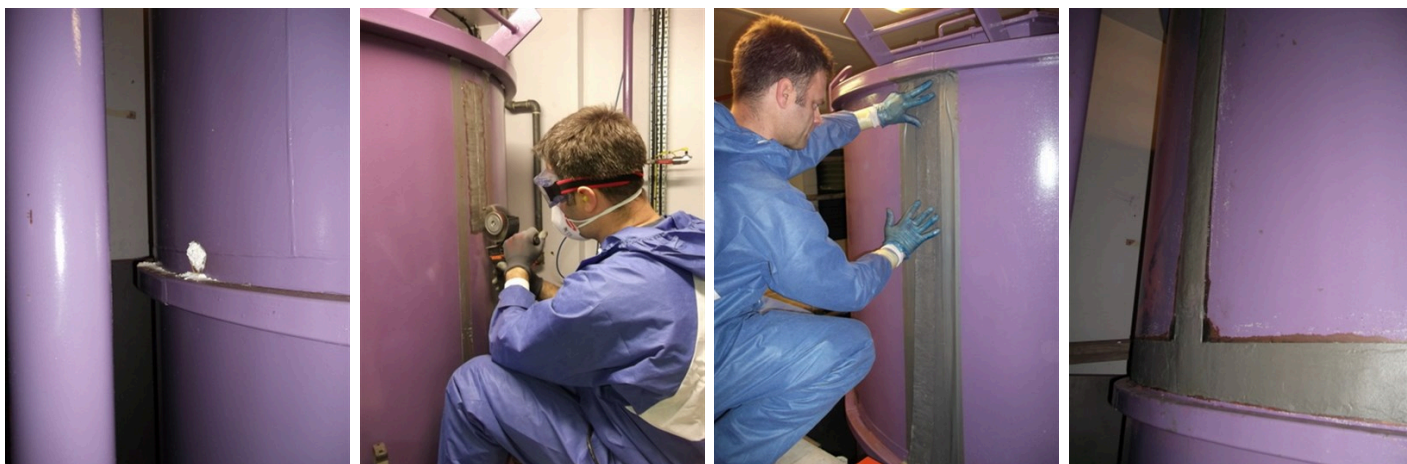
The caustic tank used as part of the process had sprung leaks along the weld seams.

- * Caustic leaking from weld seams ,
- * Surface preparation using MBX Bristle-blaster ,
- * First layer of Belzona® 1111 being applied incorporating Reinforcement Tape ,
- * Finished application ,

Application was carried out in accordance with Belzona Know-How System Leaflet TCC-1.

Re-welding the seams would have been costly, disruptive to production and ineffective. There wasn't sufficient budget to replace.
