# MAJOR BELZONA SAFETY REPAIRS IN BOTTLING HALL

**Industry:** General Industry  
**Application:** FPA-Floor Problem Areas  
**Substrate:** Concrete, Quarry tiles and epoxy coating  
**Products:** \* Belzona® 4131 (Magma Screed) ,  
\* Belzona® 5231 (SG Laminate) ,

**Customer Location:** Distillery, Glasgow, UK  
**Application Date:** November 2011

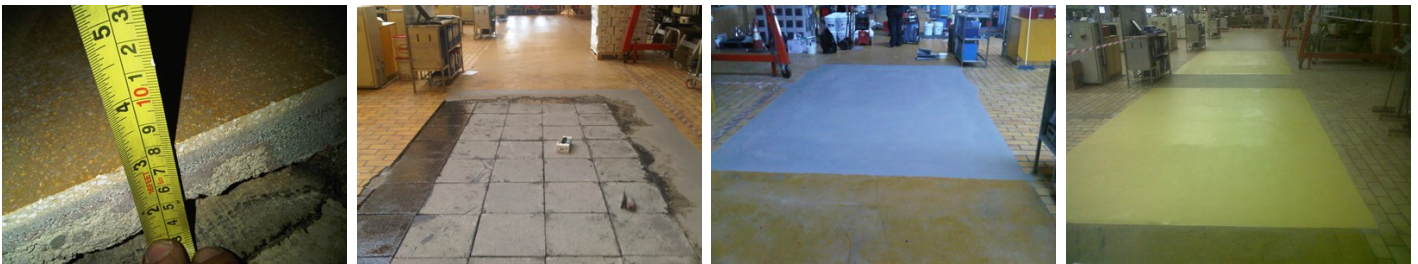
The areas were approximately 80mm deep and required filling and levelling. The three areas were a severe safety risk to the trucks operating in the plant leading to imbalance and disruption to production. The repairs had to be completed over a weekend shut-down.

- \* Depth and problem of repairs required ,
- \* Concrete slabs being bedded in prior to final Belzona® 4131 screed ,
- \* Finished screed application ,
- \* 2 coats of Belzona® 5231 with encapsulated aggregate applied for safety and grip ,

Three areas of extremely uneven flooring in the bottling hall. Areas included failing quarry tiles, epoxy screed and concrete.

Application was carried out in accordance with Belzona Know-How System leaflet FPA-1. After breaking out the failed epoxy flooring, quarry tiles and deteriorated concrete the levels were made up by bonding pre-cast concrete slabs into place before applying a 6mm screed of Belzona® 4131. Finally 2 coats of Belzona 5231, incorporating additional aggregate, were applied to create non-slip surface.
