BELZONA RESOLVES WATER INGRESS ISSUES IN SCHOOL CORRIDOR WALKWAY

ID: 3011

Customer Location: *Junior School, Chesterfield UK*
Application Date: *2010*

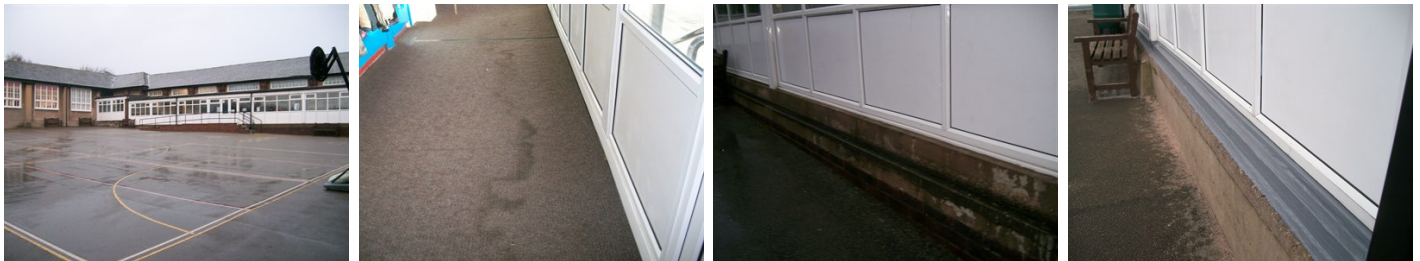
Photograph Descriptions

Approximately 8 years prior to the Belzona application the corridor walkways had been enclosed to provide a safe and warm environment for children and staff to travel around the school. Within a couple of years there was water ingress causing dampness to the carpeting and presenting a potential slip risk. The problem was identified as failing sealant between the UPVC panels and the original brick and cement rendered structures. Over the 6 years several attempts were made to reseal but all had failed.

- * View of the corridor walkway from the playground ,
- * View from within the corridor walkway with water staining to the carpet clearly evident ,
- * Close up view of the main areas of water ingress ,
- * Completed Belzona® 3131 fully reinforced application ,

The application was carried out in accordance with a slightly modified version of Belzona Know-How System Leaflet RPA-1

The repairs were carried out over two days in each of the two sections of corridor walkway. The results were a complete success

allowing the school to replace the water damaged carpet with new, confident that there would be no further water ingress issues via the Belzona® 3131 protected areas.
