BELZONA SOLVES WATER INGRESS ISSUE AT UNIVERSITY MACHINE SHOP

ID: 3013

Customer Location: University, Manchester, UK.
Application Date: October 2011

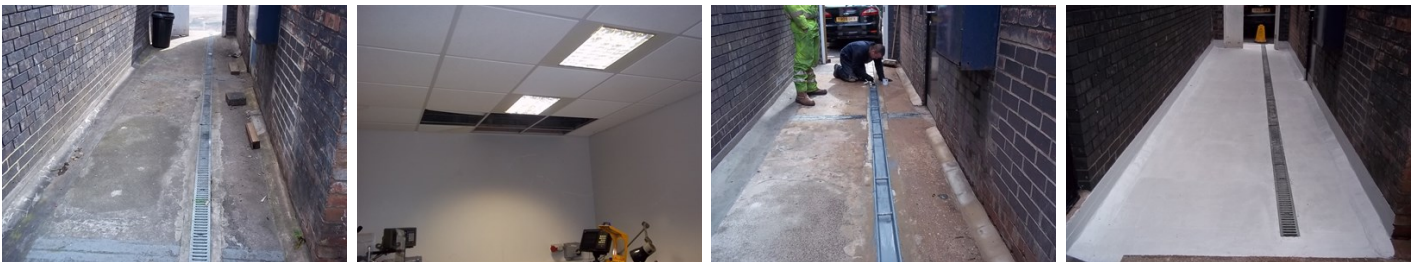
Photograph Descriptions

There had been ongoing water ingress issues into the lab machine shop over several years. A new drain had been inserted into the courtyard walkway approximately 18 months previous but the water ingress issues had deteriorated further rather than improve.

- * Initial inspection of the courtyard walkway and drain ,
- * Initial inspection of the Lab workshop directly under the courtyard walkway ,
- * Belzona® 3131 application in progress ,
- * Completed application ,

Courtyard walkway with surface water drain, the source of water ingress into laboratory machine shop below.

Application was carried out in accordance with modified versions of Belzona Know-How System Leaflets RPA-6 and RPA-8. The system comprised three coats of Belzona® 3131 with the third coat blinded out with Belzona® 9221 aggregate to improve abrasion resistance and provide positive grip

The application was completed within 4 days and has eliminated water ingress. In addition to eliminating the water ingress, by applying a third coat of Belzona® 3131 and blinding out with Belzona® 9221 surefoot aggregate, a positive grip system has been

created which is both practical in reducing slip risk and pleasing to the eye. The alternative could have been to remove the drain, recut the concrete deck and replace. This would have proved a very lengthy, disruptive and costly procedure with no guarantee of success.
