BELZONA REPAIRS CORRODED GAS PIPE AT BOILER HOUSE

ID: 3014

Customer Location: University, Manchester UK
Application Date: February 2012

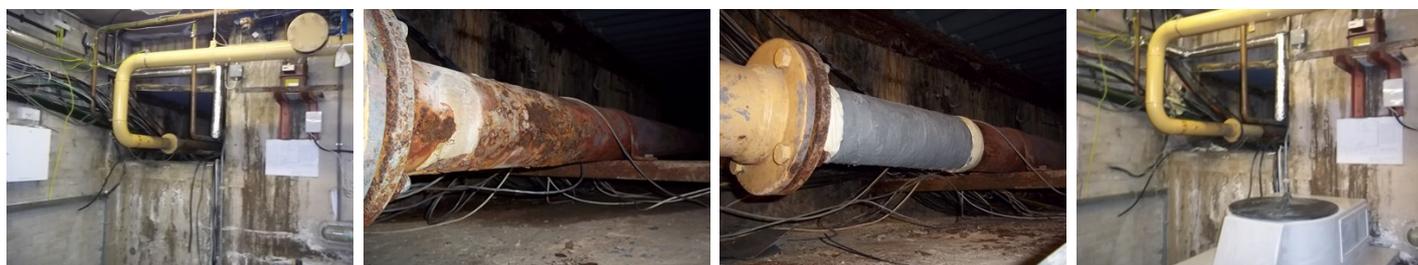
Photograph Descriptions

Following asbestos removal several years ago, a section of a gas main pipe had been left exposed to water ingress from above and as a result had suffered corrosion and metal loss. The client required a solution that was quick, easy and safe to apply to a live gas pipe, that would replace the metal loss and provide lasting protection from further corrosive attack.

- * The entry point of the Gas pipe via a service tunnel making access and application difficult ,
- * Close up of corroded section of pipe ,
- * Completion of Belzona® 1161 application ,
- * Completion of application including final coat of Belzona® 5831 ,

The application was carried out in accordance with a modified version of Belzona Know-How System Leaflet VPF-11. Belzona® 1161 was applied to rebuild and protect the badly corroded section of the pipe followed by a heavy coat of Belzona® 5831 for added corrosion protection.
