# BELZONA SAVES THIS BULL GEAR FOR A SECOND TIME

ID: 303

Bull gear and spline for 100-ton overhead crane.

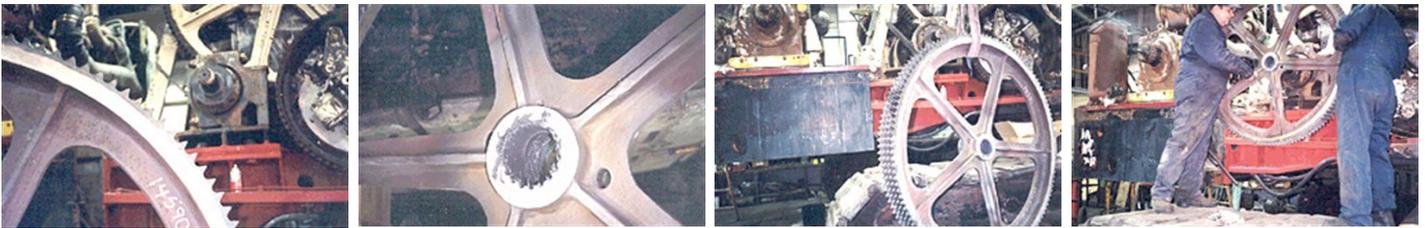
*12-years prior, the assembly was rebuilt with Belzona® 1111 (Super Metal) which needed refurbishment. Excess play in the spline made it difficult for precision movements.*

- \* Damage bull gear spline ,
- \* Belzona® 1311 (Ceramic R-Metal) applied to socket ,
- \* Lifting gear into position ,
- \* Aligning bull gear onto spline ,

Both the male spline and the female socket of the bull gear were blasted. Belzona® 9411 (Release Agent) was applied to the spline and Belzona® 1311 (Ceramic R-Metal) was applied to both, subsequently mated, aligned and indexed. There is really no affordable alternative for this 35-year old bull gear. It would have to be custom fabricated, which is both time consuming and costly.
