# BELZONA SAVES COLLEGE BALCONY AND SUPPORTING LINTELS

**Customer Location:** College, Derbyshire, UK.  
**Application Date:** July 2010

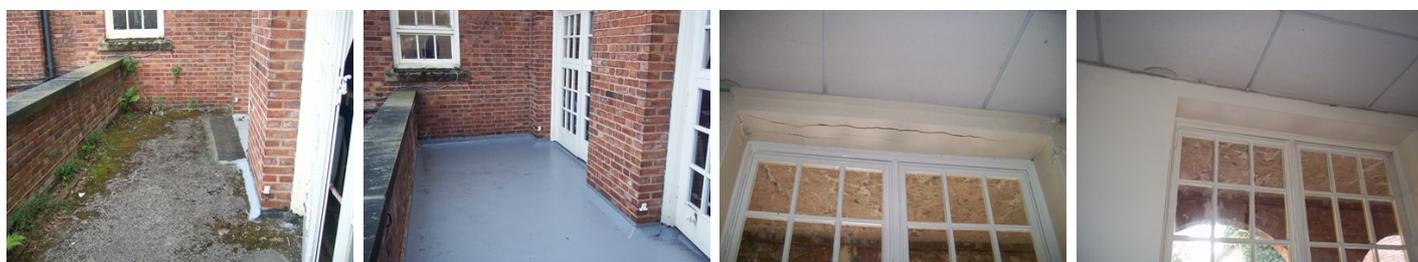
The balcony floor which also acted as a roof area for the walkway below had become porous and had been allowing water to penetrate to the ceiling and into the supporting lintels above the windows. This was causing them to spall quite badly to the point they were at risk of becoming unstable if left untreated. Several previous attempts had been made by others to resolve the water ingress by patch repairs, none of which had proved successful.

- \* Balcony floor on first inspection ,
- \* Balcony floor on completion of the Belzona® 3131 application ,
- \* The damaged lintels on first inspection ,
- \* The lintels following Belzona® 4141 repair and subsequent painting ,

The college were contemplating removal of the balcony and replacement of the lintels due to the degradation caused by continued water ingress. Belzona® 3131 provided a high performance long life solution that not only protects the balcony from further water ingress but due to its micro porous nature enables any trapped moisture to escape. Belzona® 4141 was used to repair the badly

damaged lintels. With its high bond strength, ability to repair thick sections without the need for shuttering and impermeable nature it provides a high performance long lasting solution to damaged stone and concrete
