BELZONA RESTORES BEARING HOUSING

ID: 304

Industry: *General Industry*
Application: *MPT-Mechanical Power Transmission*

Self aligning bearing housing for hydraulic ram controlling a bucket loader.

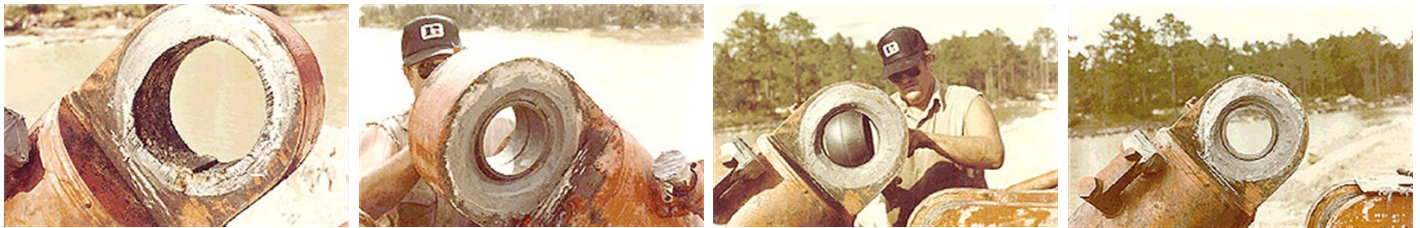
Photograph Descriptions

Large intermittent loads caused the bearing housing to become oblong and created a problem for the operator to effectively remove large buckets of earth.

- * Oversized bearing housing ,
- * Damage evident during trial fit ,
- * Cleaning off excess Belzona® 1111 ,
- * Finished application ,

The application was carried out in accordance with Belzona Know-How System Leaflet MPT-7.

The construction company had a time clause contract and didn't have the luxury to weld or get a replacement part. The Belzona Consultant sold the job on Christmas Eve and got the call for the application a week later. The repair lasted for at least three years.
