# BELZONA RESTORES CHIPPER DISC POCKETS TO LIKE NEW CONDITION

ID: 306

Application: *SHM-Solids Handling Machinery*

Customer Location: *Pulp and paper mill in Washington, USA*

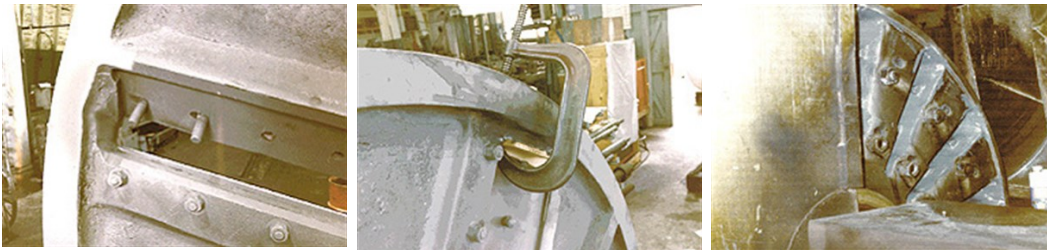
*These chipper disc pockets are worn from continuous wood abrasion and eventually were unable to produce satisfactory chips.*

- \* Significant metal loss on the exit side of the pocket ,
- \* Knives C-clamped into the wet Belzona ,
- \* Two coats of Belzona® 1321 for a finished smooth surface ,

The application was carried out in accordance with Belzona Know-How System Leaflet SHM-13. The actual knives were rebuilt using C-clamps to form the exact shaft of the pocket without machining.

Rejects are minimized by restoring the pocket profile, and all the pockets are able to be rebuilt at once.
