BELZONA RESTORES CHIPPER DISC POCKETS TO LIKE NEW CONDITION

ID: 306

Application: *SHM-Solids Handling Machinery*

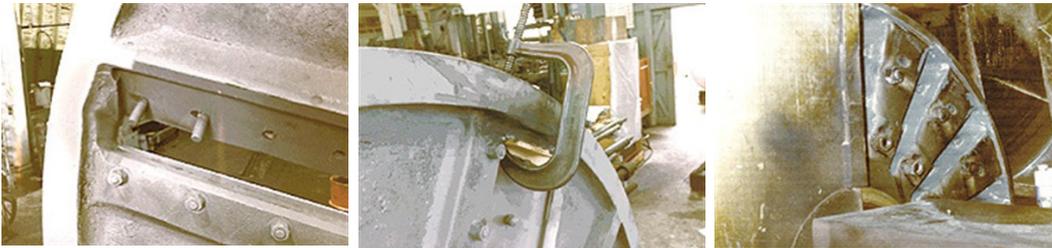
Photograph Descriptions

These chipper disc pockets are worn from continuous wood abrasion and eventually were unable to produce satisfactory chips.

- * Significant metal loss on the exit side of the pocket ,
- * Knives C-clamped into the wet Belzona ,
- * Two coats of Belzona® 1321 for a finished smooth surface ,

The application was carried out in accordance with Belzona Know-How System Leaflet SHM-13. The actual knives were rebuilt using C-clamps to form the exact shaft of the pocket without machining.
