BELZONA UPGRADE TO LARGE TRANSFORMER

ID: 3090

Customer Location: Power plant, North of France
Application Date: January 2012

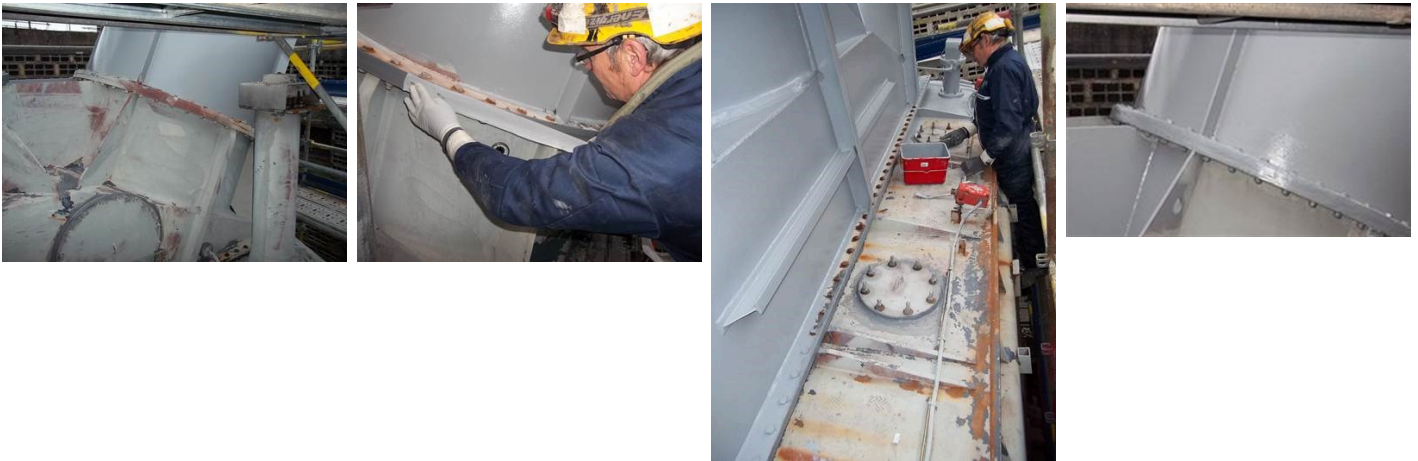
Photograph Descriptions

Oil was leaking from many of the flanges. Replacing the seals was not an option. This would have required draining the 42 tonnes of oil from the transformer as well as individually dismantling the 70 flange faces, a very time-consuming task.

- * Original condition of the flange faces ,
- * Repair with Belzona® 1161 and Belzona® 9341 ,
- * Belzona being applied to encapsulate the bolts ,
- * Finished application. ,

Application was carried out in accordance with Belzona Know-How System Leaflet VPF-11a.. After the surface was prepared using an MBX Bristle Blaster followed by degreasing the substrate, Belzona® 1161 and Belzona® 9341 (Reinforcement tape) were applied onto the whole surface of the flange faces in order to stem the leaks.

Belzona offered a cost-effective solution to the client to cold-seal the leaking flange faces without the need to drain down the oil. The application only took two weeks to complete, far less than the alternative of replacing the seals, and allowed a quick return in service of the transformer.
