# BELZONA PROTECTS WASTE WATER TANK ON FERRY

ID: 3096

Waste water tank on a passenger ferry operating between Sweden and Finland.

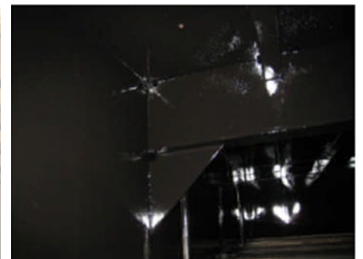
*The corrosion was due to fermentation of sanitary and food waste. The previous corrosion protective system was based on Vinyl ester and had become loose and failed.*

\* Passenger ferry Tank internals grit blasted First coat in beige colour had been spray applied and stripe coating of details with black carried out The final result after application of the second coat of Belzona® 5811 ,

Application was carried out in accordance with Belzona Know-How System Leaflet TCC-5. Fillets and edges were coated by hand application before the whole area was coated with two coats of 5811 by airless spray application.
